## Outfall and Channel Restoration

## West Tollgate- GIS Mapping

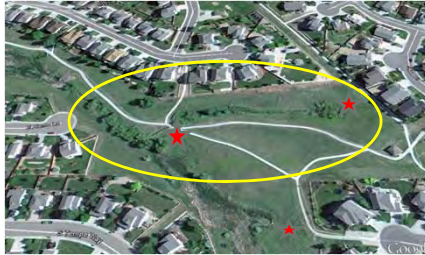
Channel in 2010- trees and wetlands expanding, outfalls becoming blocked

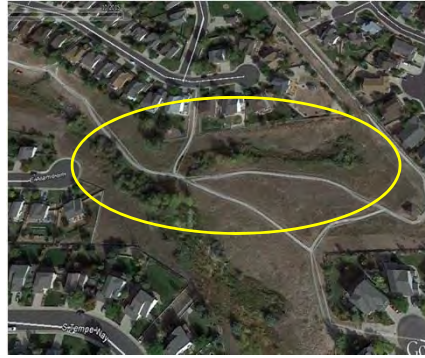
Channel in 2015- trees continue to grow, cattails grow/die and add to biomass in channel- outfalls blocked

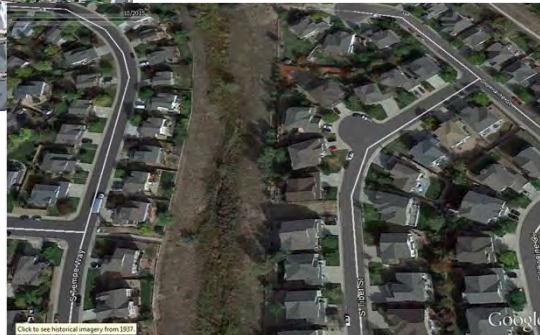
Channel in 2015- outfalls blocked, trees established, cattails expanding, capacity being compromised

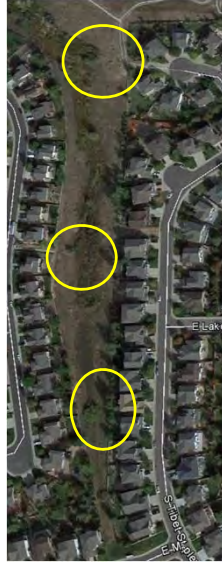
Access to outfalls to perform maintenance does not exist- needs to be constructed

Outfalls blocked, trees and vegetation continue to expand

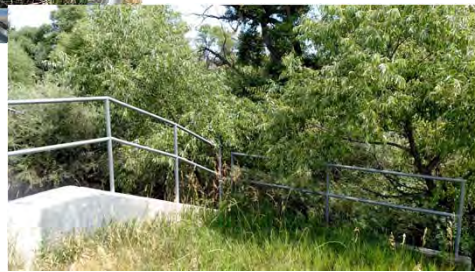
Trees adding to dense vegetation- but not yet blocking 54" outfall into pond

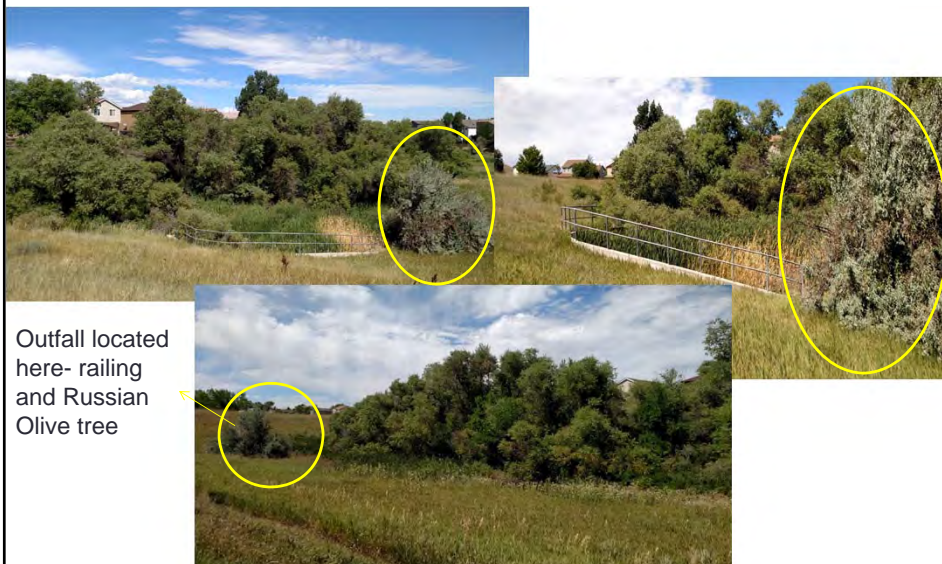
Outfall located here- railing and Russian Olive tree

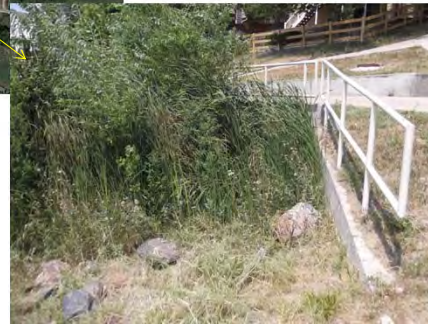
2014- Continued growth of cattails in pond, outfall becoming blocked

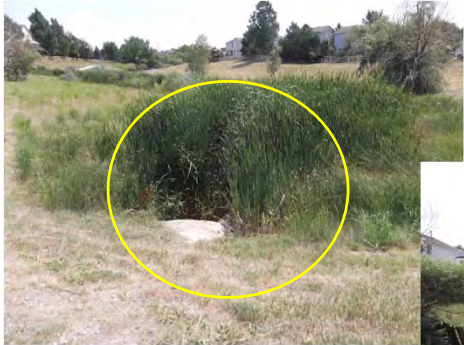
Outfall draining into West Toll Gate- dense cattails with potential capacity issues

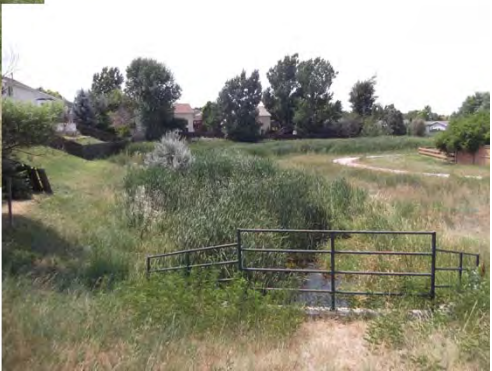
Pond outlet structure- needs some work- access is available, Nationwide Permitting under NWP 43

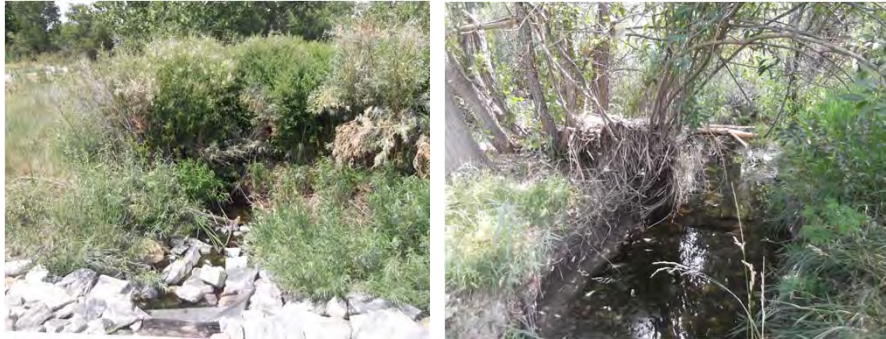
Dense vegetation in channel bottom, causing a debris catch at numerous locations

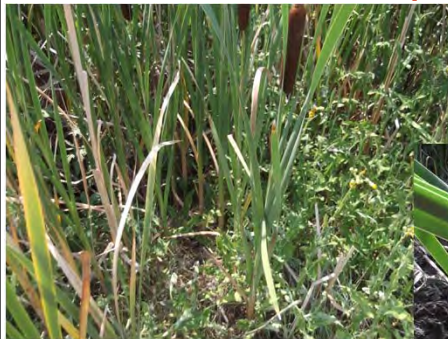
24" outfall completely grown over and cannot be located- or can it?

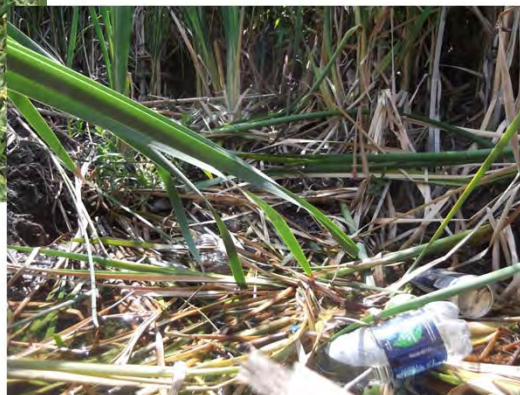
24" outfall located after knocking down vegetation. Channel invert is higher than top of pipe- 30" of sediment and vegetation to be removed
